ANALYSIS OF THE UNDERGROUND POWERHOUSE
ARCH AT THE PORTAGE MOUNTAIN DAM

A THESIS

DEPARTMENT OF GEOLOGY

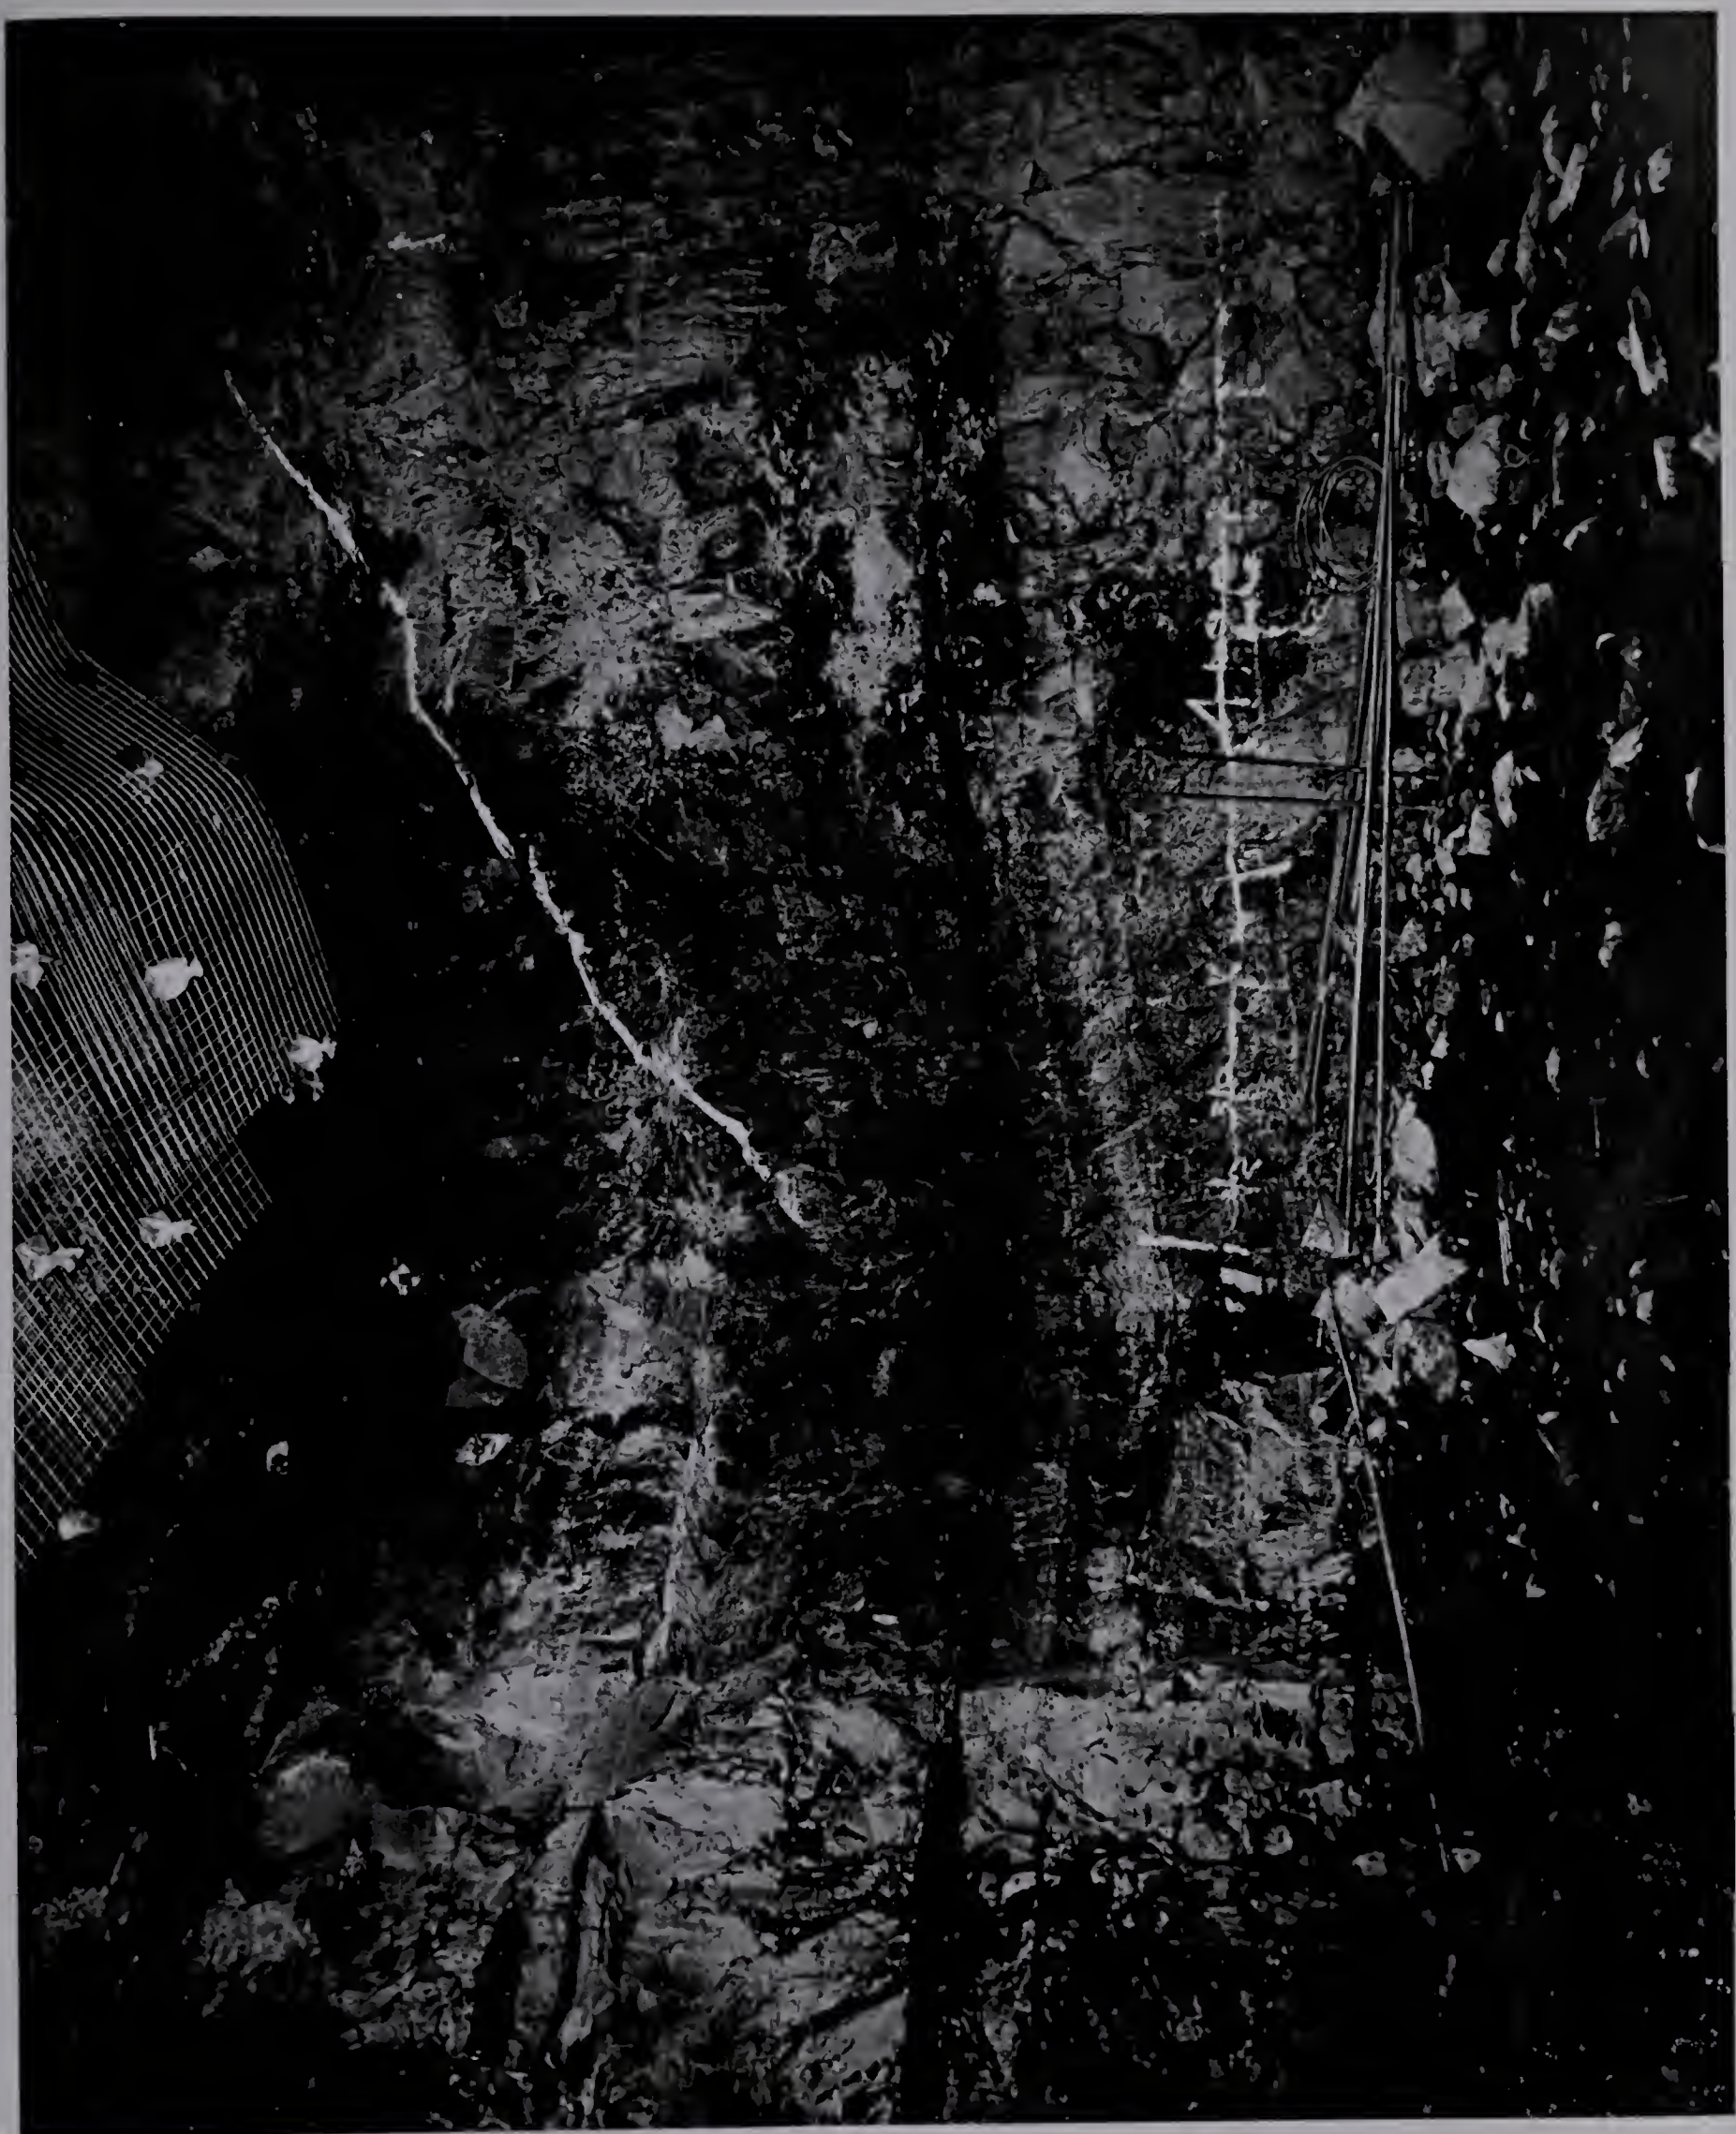
Arch at Station 4 + 20 Showing Overbreak to Coal Seam which
occurred for Full Length of Powerhouse
